**Report to The Tributary Committees
October 12, 2017**

PROJECT NAME: Cottonwood Bridge Removal
PROJECT NUMBER: 2017-01 RR
SPONSOR NAME: Chelan-Douglas Land Trust
LANDOWNER NAMES: CDLT, Crone, Deskin

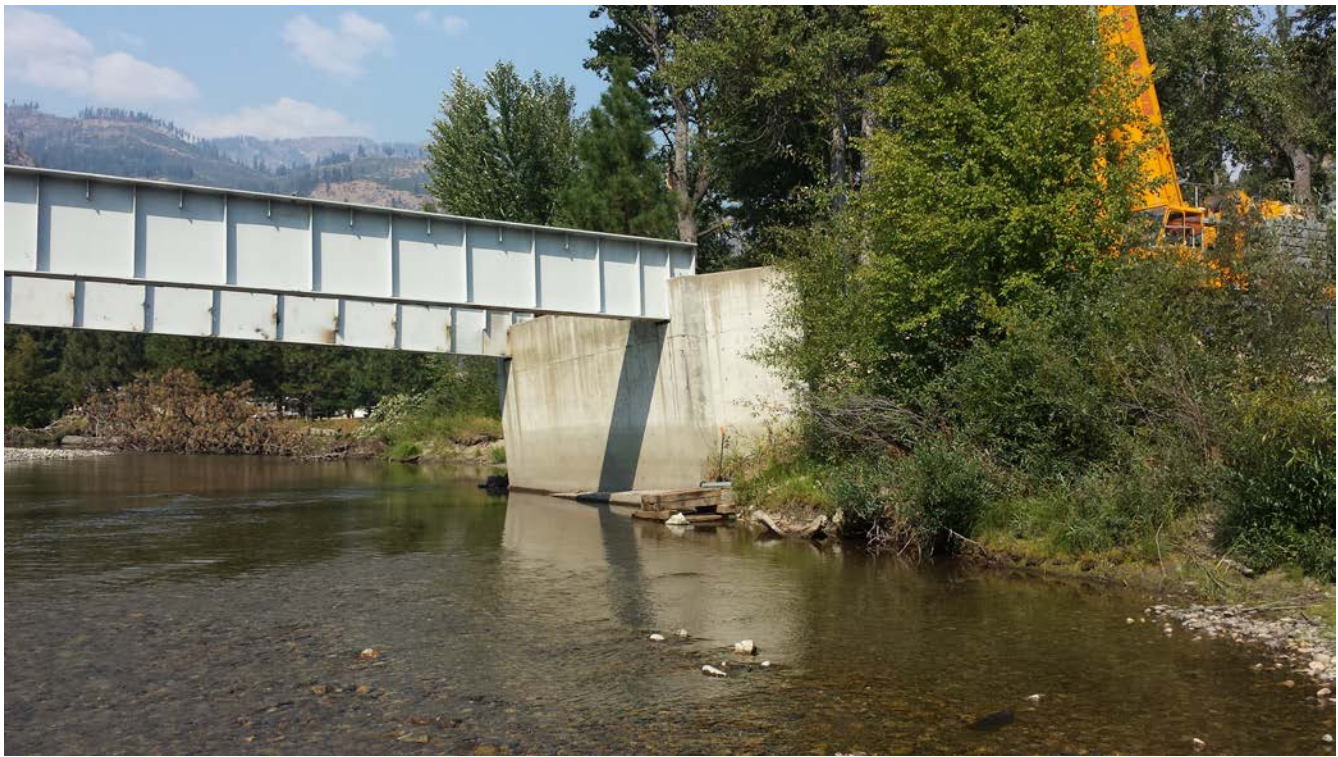
4. After all this was done and the crane was in place, the evening before it was set to remove the beams, the left abutment moved abruptly, tilting about 2' towards the river. Luckily no harm was done. Rather than begin the lift the next day, the crane operator required additional analysis, causing the primary contractor to hire an engineer to assess the situation from a crane safety perspective, leading to several steps of additional preparation including cable anchors on the landward side of the abutment, and about a week of extra crane rental time. The crane first had to move out of the way, then it moved back and successfully completed the job.

5. The condition of the left abutment presented a real possibility of falling into the river exposing a large amount of erosive material behind it to seasonal high flows. Working together with WDFW we determined the best thing to do is remove most of the abutment above the OHW line and stabilize the exposed dirt behind it. This will address the immediate concerns in a cost-effective and permit-compliant manner, leaving the non-emergency aspects to be completed during the large habitat restoration project.

Photo taken September 19 looking upstream the morning after the abutment shifted
