**Icicle Irrigation District Flow Control Structure Project (2014-02RI)**

**Final Report**

***Project Sponsor – Chelan County Natural Resource Department***

***Tributary Committee Grant Number – 2014-02 RI***

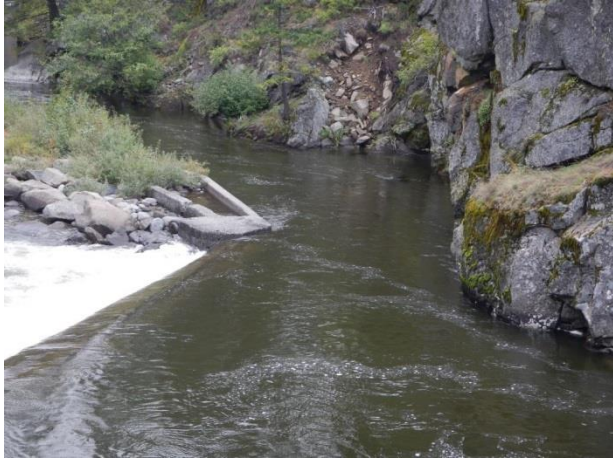
**Before**

The above picture on the left shows how flow entered the irrigation canal unrestricted even when the canal was not in use. The picture on the right shows the new flow control structure with flashboards installed, prohibiting flow from enter the canal. The picture below shows the newly constructed boulder clusters just below the diversion dam.

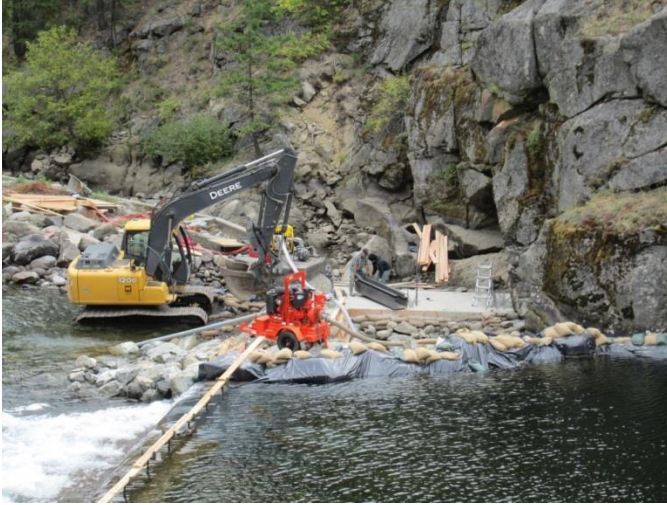
The main challenge for this project was the construction of the cofferdam and the de-watering of the isolated work area. Higher than expected stream flow in Icicle Creek, the porous nature of the streambed and the bedrock formation which forms the right side of the canal entrance made it difficult to isolate and de-water the work area. Additional time and resources were spent on construction of the cofferdam and an additional pump was needed to de-water the work area. The picture below shows the additional 4” pump (orange pump) that was needed to de-water the work area. It also shows the bedrock formation which made sealing the cofferdam difficult.
